# Manhole Inspection Summary

Manhole # S3700\_037MH

Insp Date: **1/29/07 8:14 AM**

**Location** Address: **410 23RD ST**

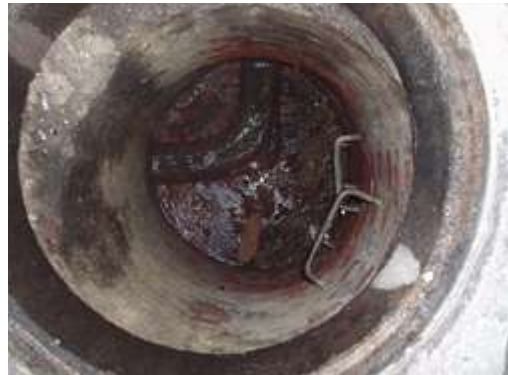
Top View

Evidence of surcharge - Bench debris.

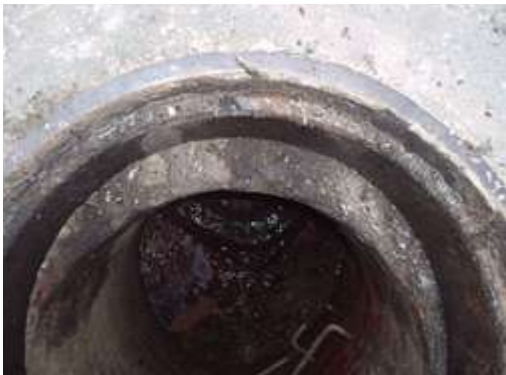
Defect

Frame leaks. Frame offset. Corbel infiltration.

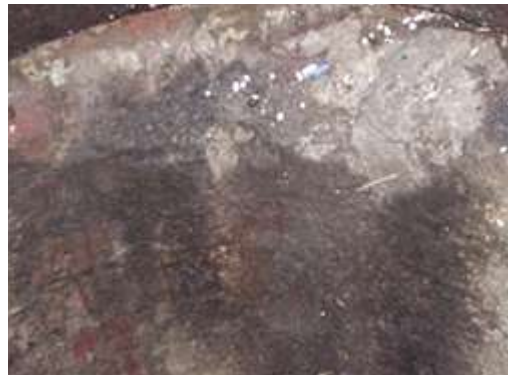
Defect

Frame leaks. Corbel deterioration and infiltration.

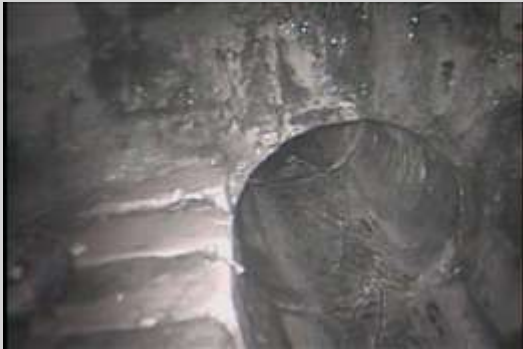
### 8 in. Circular Gravity Sewer Pipe Out @ 12 O'Clock

Invert Depth: **9.30** (ft.) Flow Characteristics: **Slow**

Infiltration: **None** Pipe Seal Cond: **Unknown**

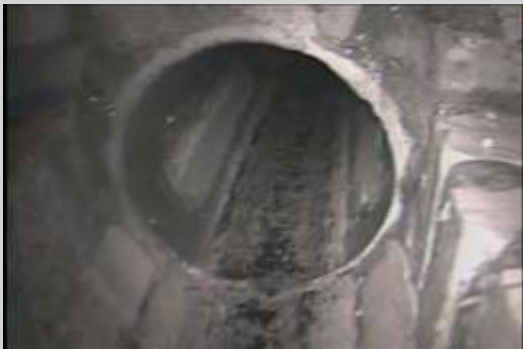
### 8 in. Circular Gravity Sewer Pipe In @ 9 O'Clock

Invert Depth: **9.25** (ft.) Flow Characteristics: **Slow**

Infiltration: **None** Pipe Seal Cond: **Unknown**
